**New Method for Drying  
SF6 Insulated Substation Assets**

**John Eastman**

**INCON Power Reliability Products  
Saco, Maine USA**

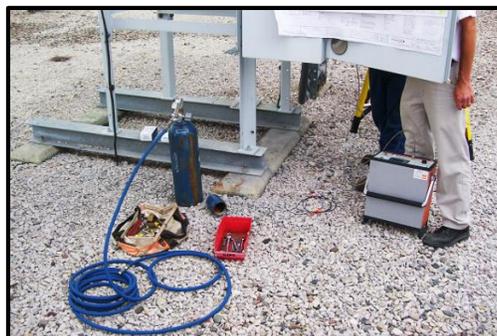
Water can enter equipment in a few ways. If an asset leaks SF<sub>6</sub>, then it must be refilled occasionally to keep it in service. Unless personnel are trained and extreme care is used in storage and use, the filling equipment itself can be covered with moisture and the moisture will ride into the asset with the SF<sub>6</sub>. Laying the equipment on the ground on a humid day is not considered “best practice” for SF<sub>6</sub> equipment handling.

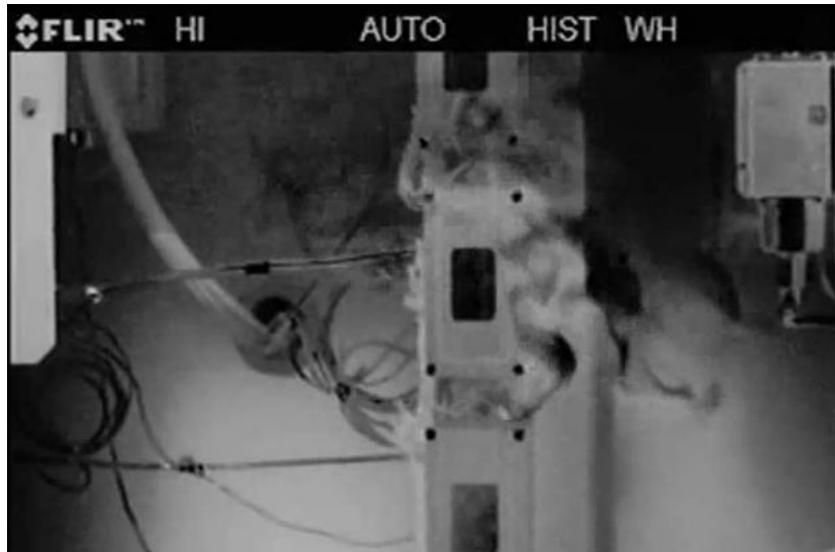
Another pathway is for the moisture to enter the asset through the leak site. Though counter-intuitive, even though SF6 is leaking out, water can enter through the same hole due to the difference in molecule size as described by Graham's Law of Effusion. Here is a still picture of a gas leak from an SF6 pressure switch bellow, taken with an infrared camera.

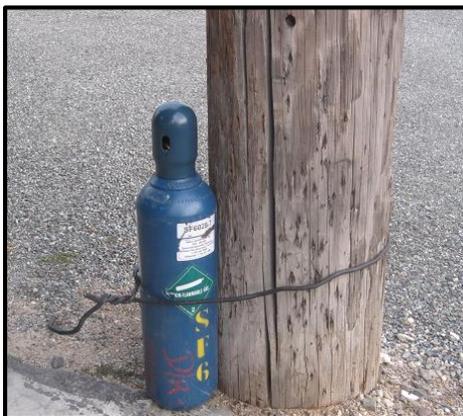
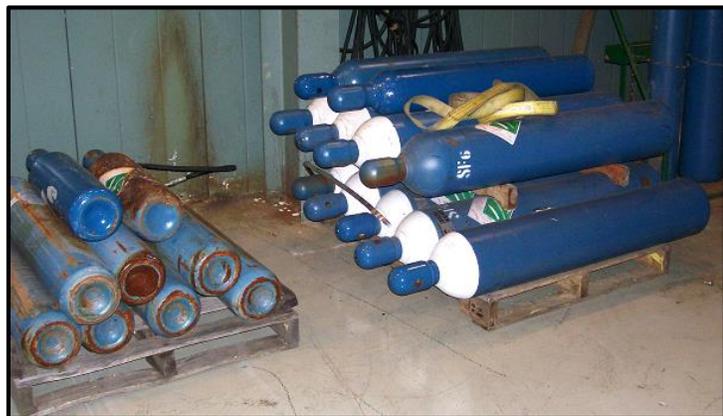
Still another way is mistakenly filling a circuit breaker with wet SF6 that has been removed from some other asset. Marking the cylinders is very important so technicians know.

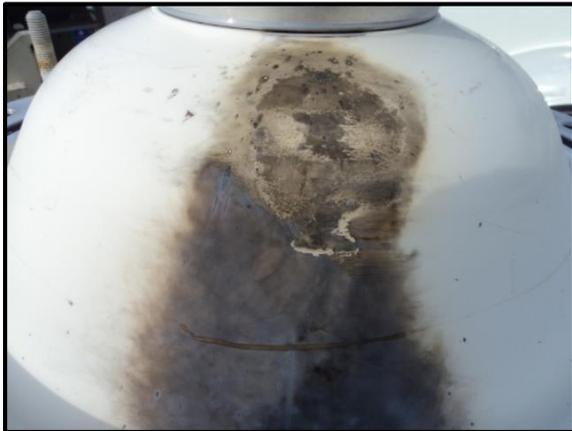
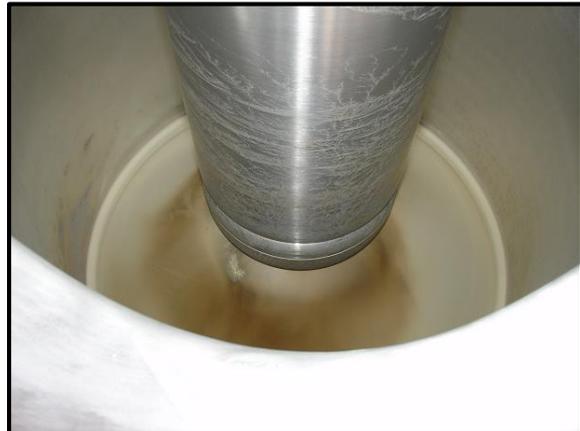
If a circuit breaker has never leaked gas and never been refilled, chances are good that moisture is not a problem if the original filling was with dry gas. In the normal operation of a circuit breaker to interrupt fault currents, the arcing dissociates SF<sub>6</sub> into other molecules. SF<sub>6</sub> readily heals and recombines but some does not and is the white, foul-smelling sulfurous powder seen in circuit breakers when they are dis-assembled. This powder, when combined with water, creates corrosive sulfuric acids which attack the metals and other materials of the circuit breaker. As the water builds up inside, the internal desiccant bag that is installed during manufacture is exhausted and can hold no more water. At this point, water build up within the breaker is more rapid and can simply puddle at the bottom of the interrupter. Water as frost is not such a great problem. Frost has a much higher dielectric strength than the liquid phase. Water in the liquid phase contaminates the surfaces of internal stand-offs and insulation, encouraging a flashover to ground, particularly for GIL and GIS systems where there are many standoffs. Damage caused by SF<sub>6</sub> contamination for GIL internal standoff insulators is show here:

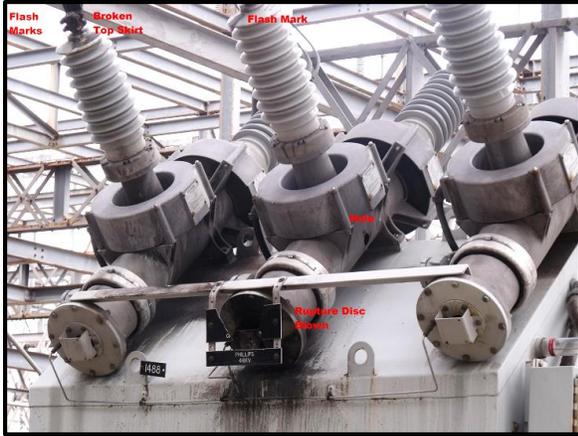
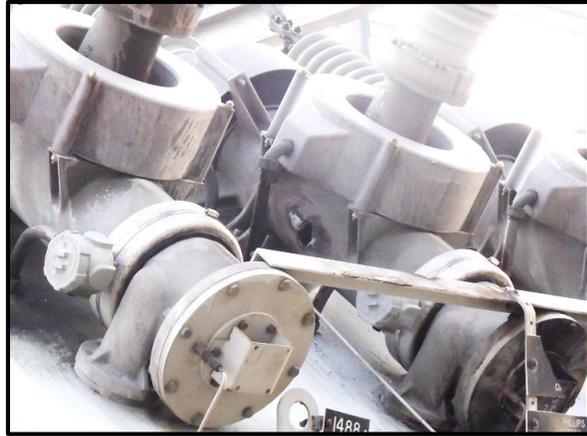
Below is shown a case where the breaker required many fills over its 35-year life. The leak site admitted enough water over the years to cause the center phase to flash-over; and internal phase to ground fault.

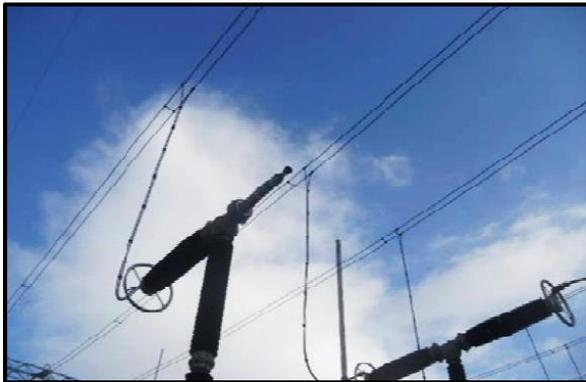
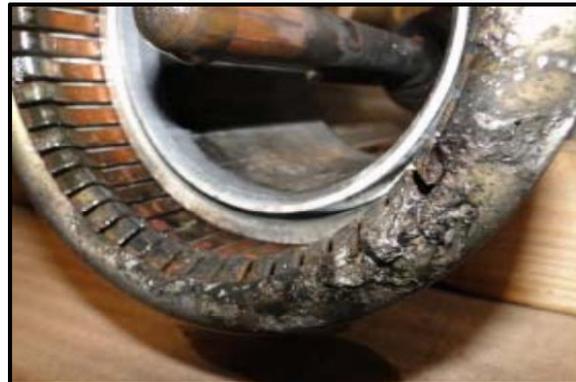
The center phase ruptured, all the SF<sub>6</sub> was released to atmosphere. The force of the blast shattered porcelain and damaged nearby equipment. This failure cost the utility over \$250,000. Disassembly of the other two poles revealed standing water puddled at the base of the interrupter.

Low SF<sub>6</sub> density and moisture build-up were the cause of this failure to interrupt the arc, which continued to burn until the interrupter melted.

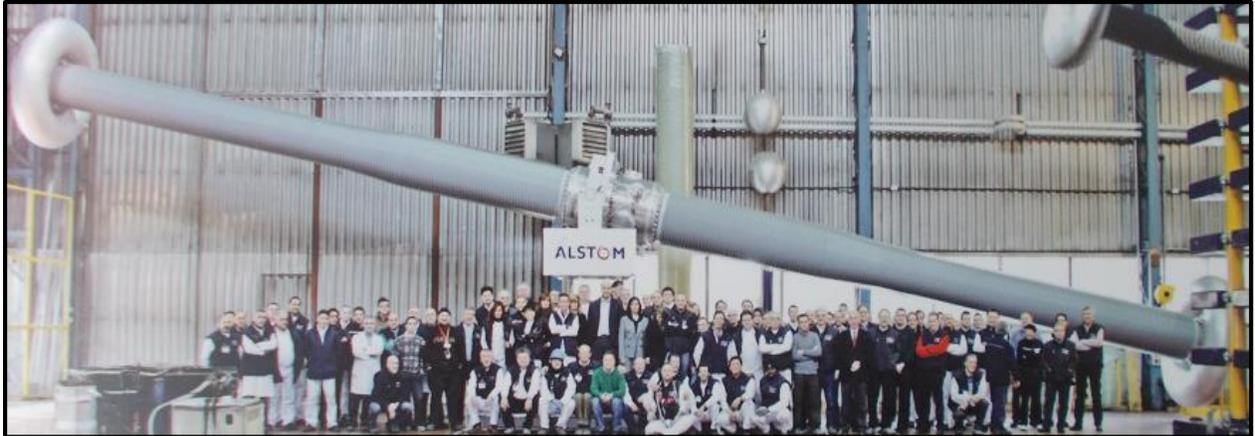
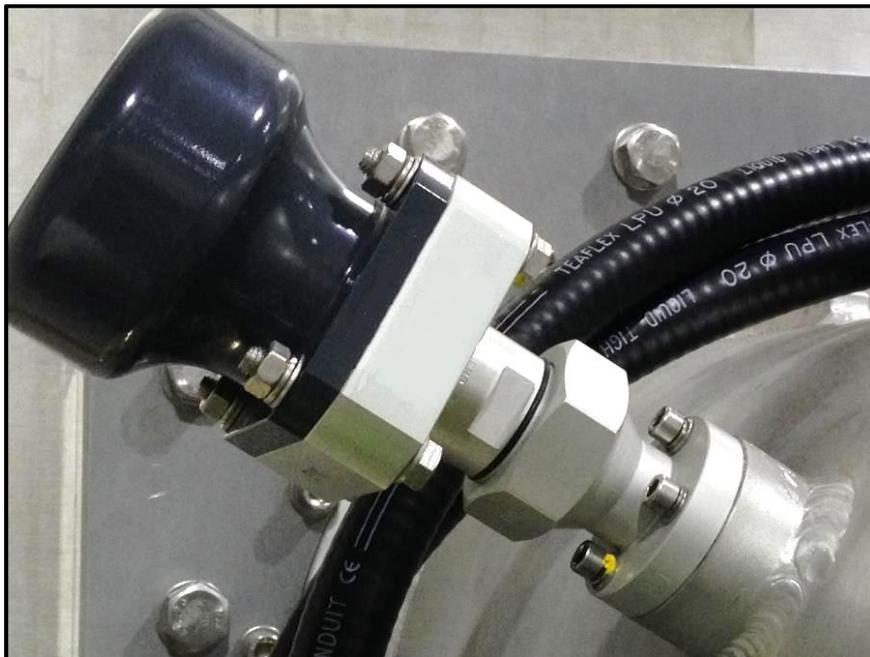
The concept is well proven on EHV bushings destined for 1100 KV DC converter stations. The large amount of polymer and other process materials includes some small amount of water; it is impossible to avoid. Three such devices are used on this particular bushing to absorb moisture that is released by internal materials. This bushing is half oil insulated and half SF6 insulated. The right hand side holds 600 pounds of SF6. Three absorbing units are used on the right hand side at the mounting flange.

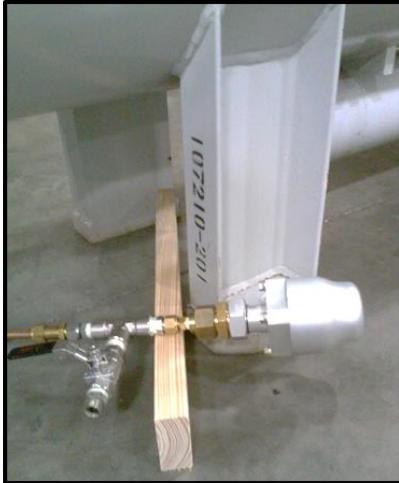
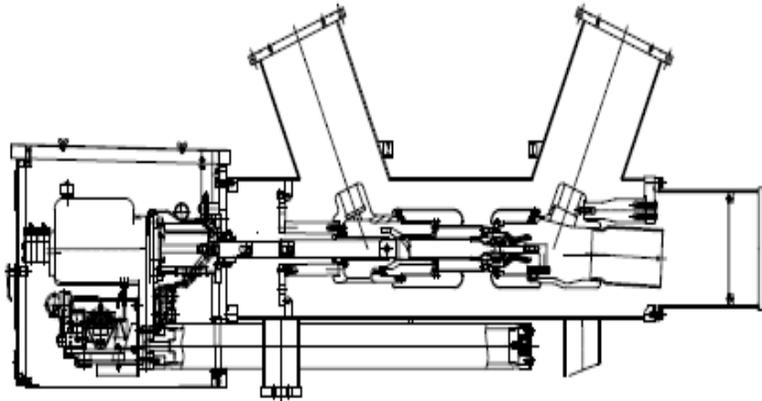
The absorber device was plumbed to a filling port, as shown.

Length of interrupter tank 2.92m; diameter of tank 0.59m; diameter of bushing wells 0.44m

A single pole of a 362Kv Dead-Tank IPO circuit breaker was used in the test. First, a vacuum was applied to the interrupter tank to 1 inch of Mercury.

Then, at the opposite end of the tank, 30 ml of water was injected using a syringe. After that, dry virgin SF<sub>6</sub> with a frost point of -41C was introduced and a pressure of 5.2 bar was maintained.

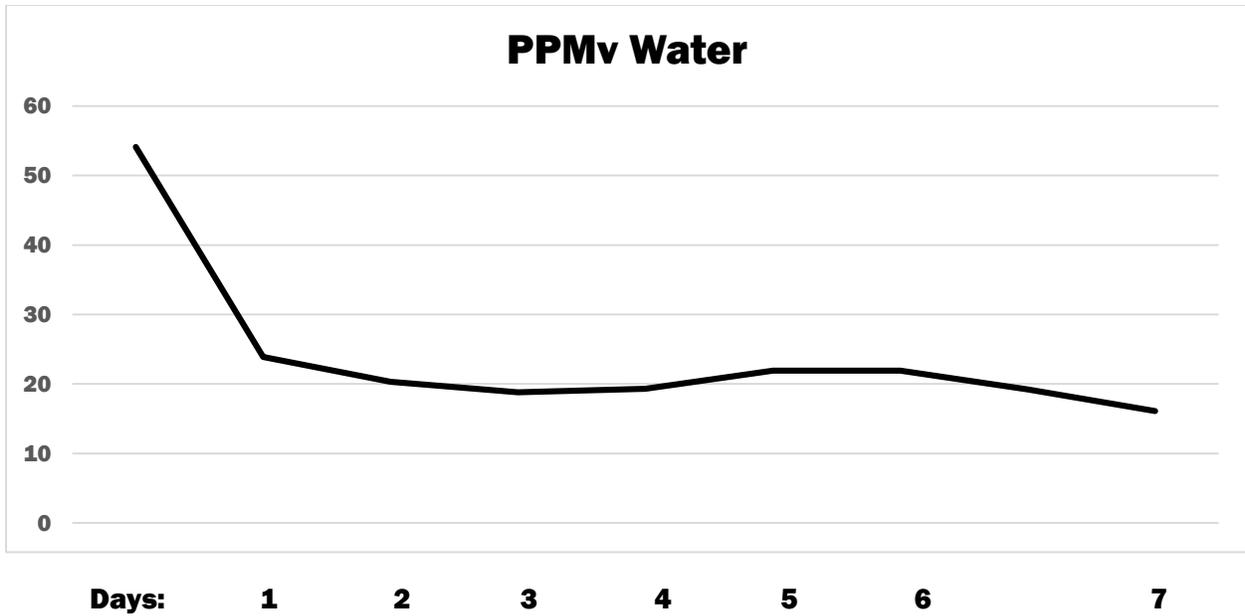
The test data clearly shows rapid moisture content decrease.

Days 5 and 6 were weekend days when the air conditioning was set to a warmer temperature, affecting the partial pressures slightly, shown as a small increase in moisture on those days

<b>Date</b>	<b>Time</b>	<b>Frost Point °C</b>	<b>PPMv Water</b>
8/24/15	6:30	-31.3	54.1
8/25/15	6:30	-38.8	23.9
8/26/15	9:30	-40.2	20.3
8/27/15	6:20	-40.9	18.8
8/28/15	6:10	-40.7	19.3
8/29/15	8:20	-39.5	21.9
8/31/15	6:10	-40.7	19.2
9/1/15	6:20	-42.2	16.1

It was surprising how a passive device at the end of a pipe would become intimate enough with the SF6 to remove moisture very quickly. We were very surprised by how effective it was. Actually, the small pipe may serve to increase gas velocity in normal convective movement. Installation and removal was easily understood; any technician can do it.

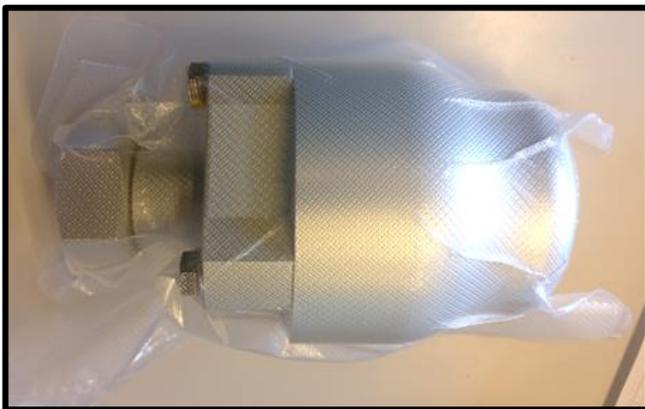
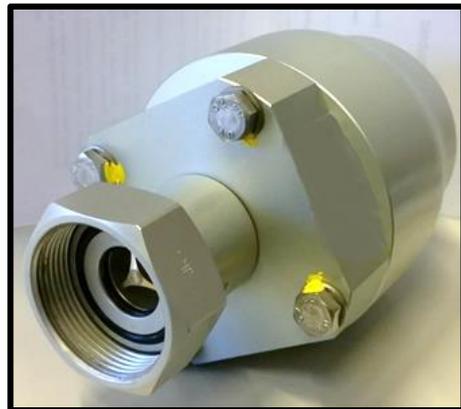
The device is in production. It is supplied in a vacuum-sealed bag to keep it clean until needed for use. The absorber is filled with dry SF6 to 1 bar. The standard fitting is 20 mm DN-20 which is self-sealing, so the SF6 is sealed in until use and desiccating material stays dry. There is little risk of introducing contaminants into the asset during assembly.

All standard SF6 fittings are available. Although the Malmkvist (abb) fitting is not self-sealing on the male end, we have designed a modified Malmkvist which does self-seal and is compatible with any standard Malmquist fitting.
